Manhole Inspection Summary

Manhole # S31EE_015MH

Insp Date: **1/25/07 9:32 AM**

Location Address: **201 PRESTON ST**

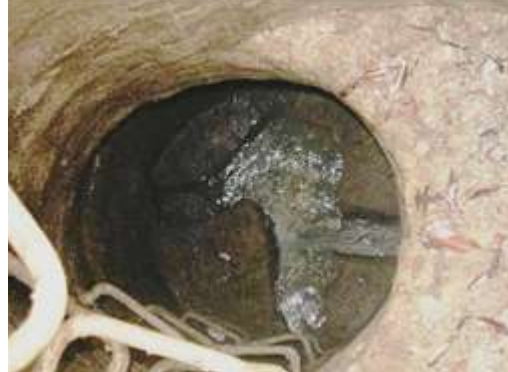
Top View

☐ Parged ☒ **Debris** (not Condition related)

Count: **11** Missing: **0** ☒ **Corroded**

☒ **Evidence Of Surcharge**

Corroded steps. Evidence of surcharge - Bench debris.

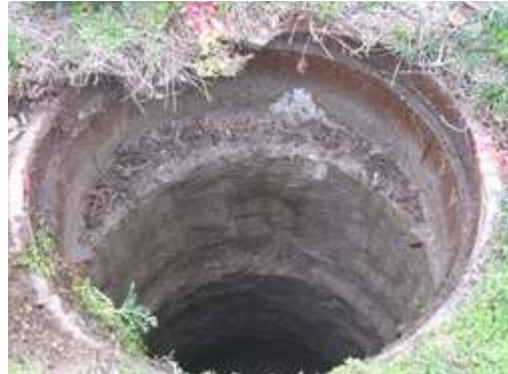
Defect

Offset: **5** (in.)

Infiltration: ☐ None ☒ **Joint** ☐ Cracks ☐ Mortar ☐ Roots ☒ **Wall**

Frame offset. Adjustment infiltration.

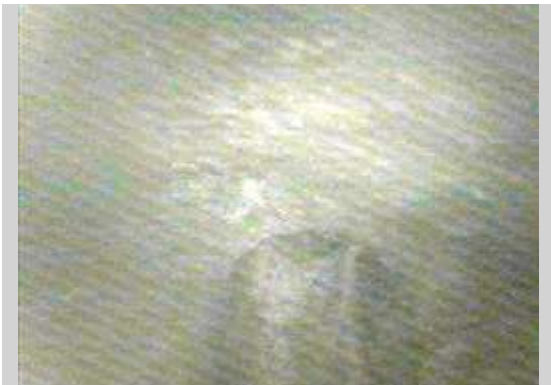
18 in. Circular Gravity Sewer Pipe In @ 3 O'Clock

Infiltration: **Evidence** Pipe Seal Cond: **Unknown**
